2019 Toyota Tacoma 4x4 Double Cab V6 Manual TRD Sport

VIN # 5TFCZ5AN0KX180696

INSPECTION DATE:
NOVEMBER 21, 2020 @ 15:50

ORIGINAL INSPECTION

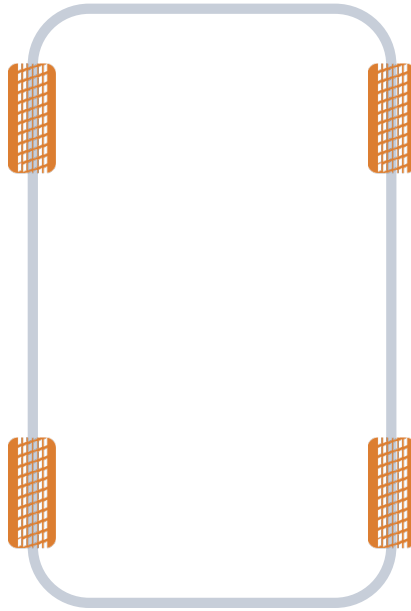
LEFT FRONT

Is Medium Worn

Medium Signs of Wear

5/32, 4/32
