**2009 BMW 3 SERIES** 4dr Sdn 323i RWD

VIN # **WBAPG735\*A\*\*\*1024**

INSPECTION DATE:  
SEPTEMBER 22, 2022 @ 18:07

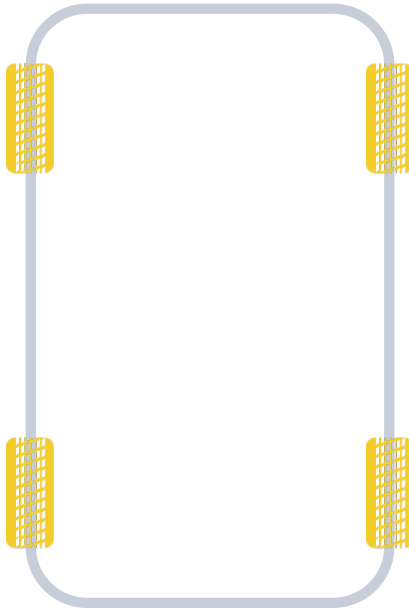
**LEFT FRONT**

Is Minor Worn

Minor Signs of Wear

8/32, 7/32, 6/32
